Manhole Inspection Summary

Manhole # S49GG_048MH

Insp Date: **8/8/08 9:53 AM**

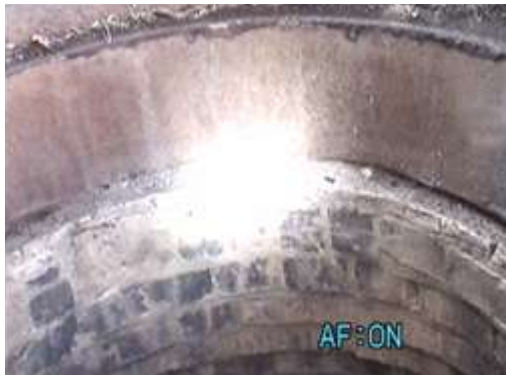
Defect 1

Infiltration

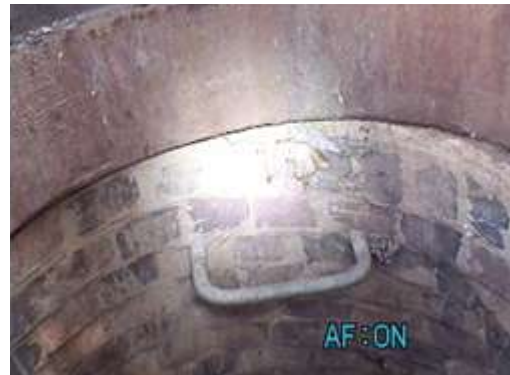
Defect 2

frame leaks

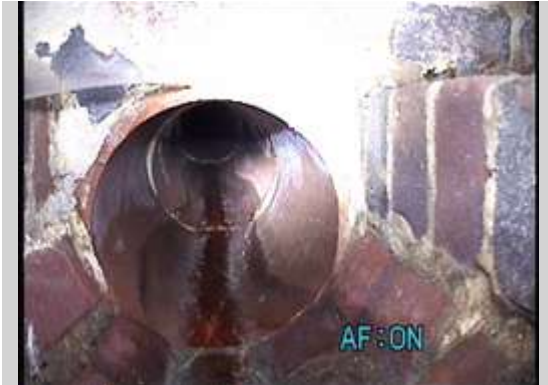
12 O'Clock Outflow

8 in. Circular Gravity Sewer
Pipe Out @ 12 O'Clock

Infiltration: **None** Pipe Seal Cond: **Sound**

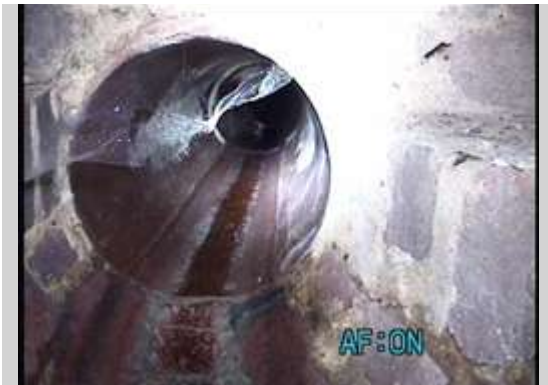
9 O'Clock Inflow

8 in. Circular Gravity Sewer
Pipe In @ 9 O'Clock

Infiltration: **None** Pipe Seal Cond: **Sound**
